RESTORATION REPORT

A 494

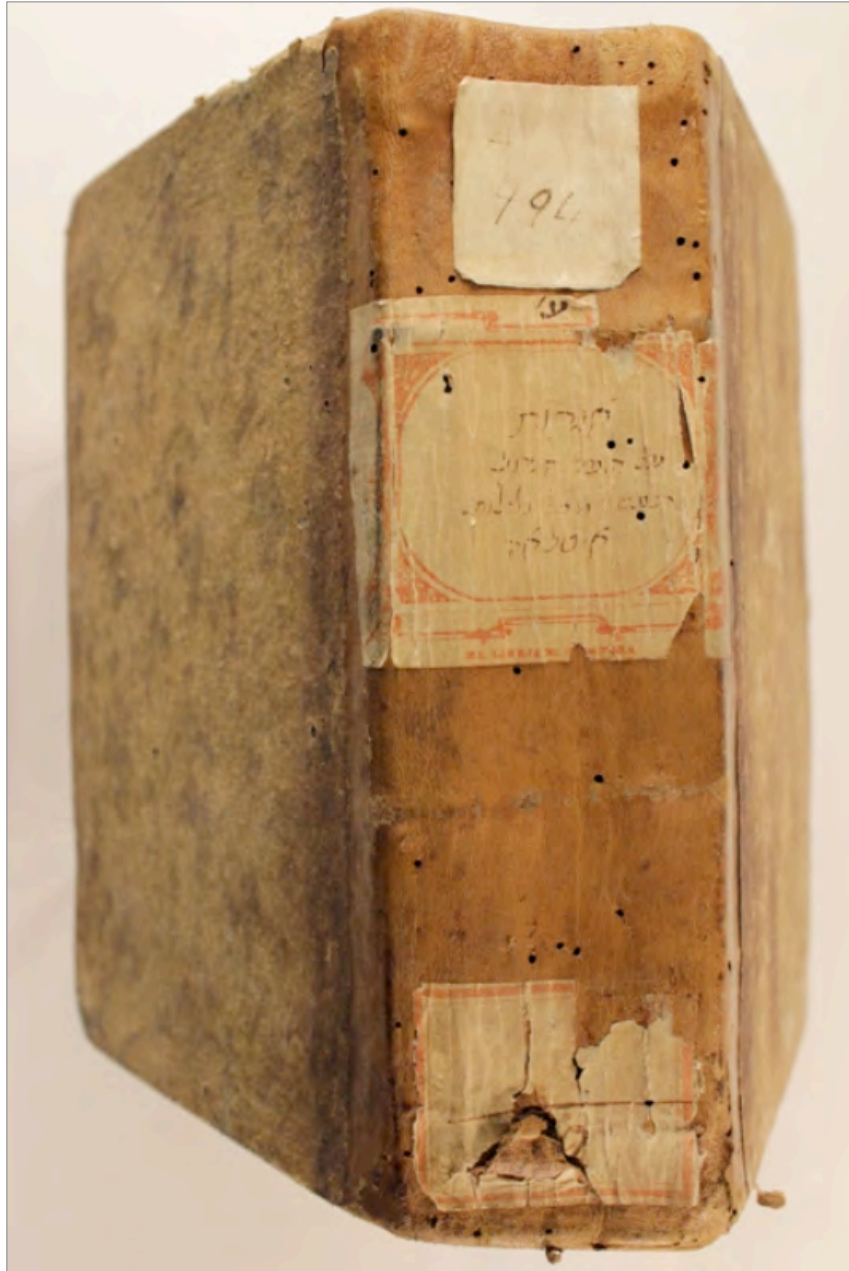
1. The volume before treatment

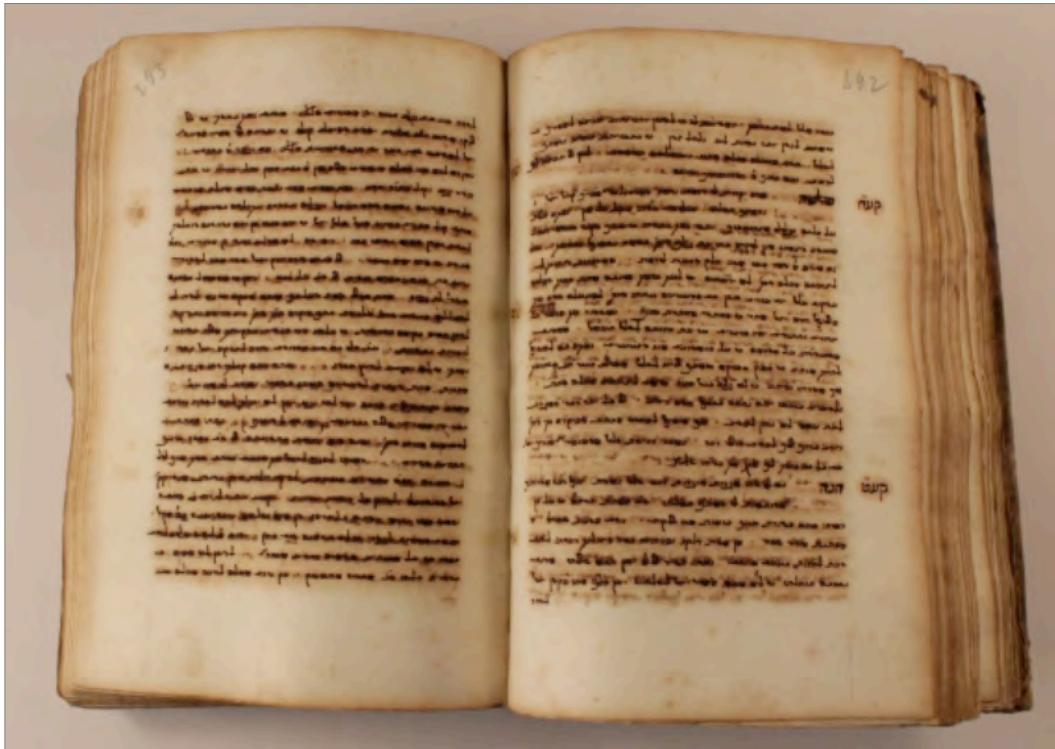
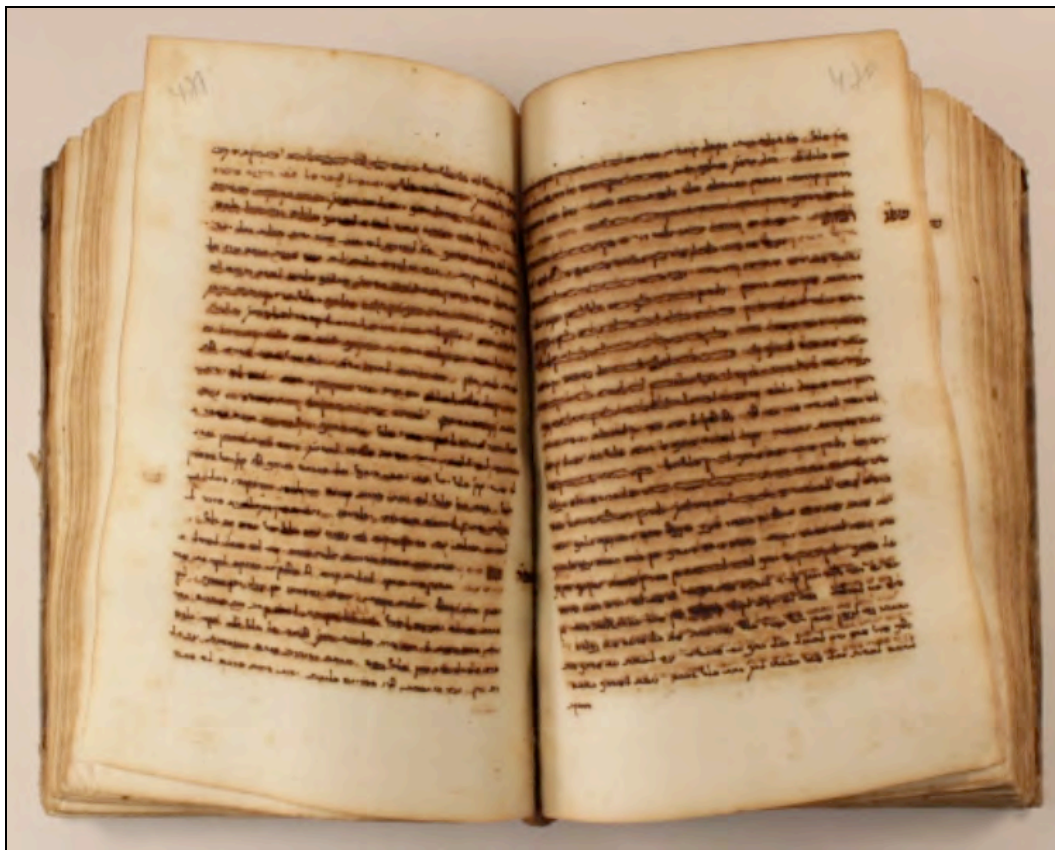
4-5. Iron gall ink corrosion

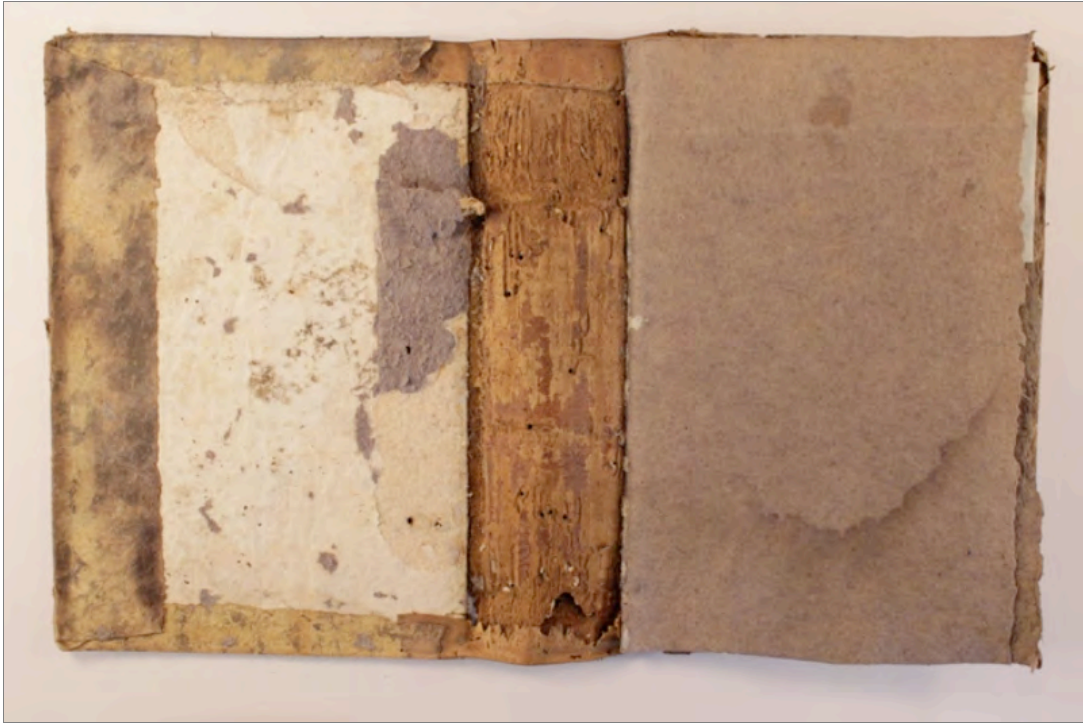
6. The disbound binding

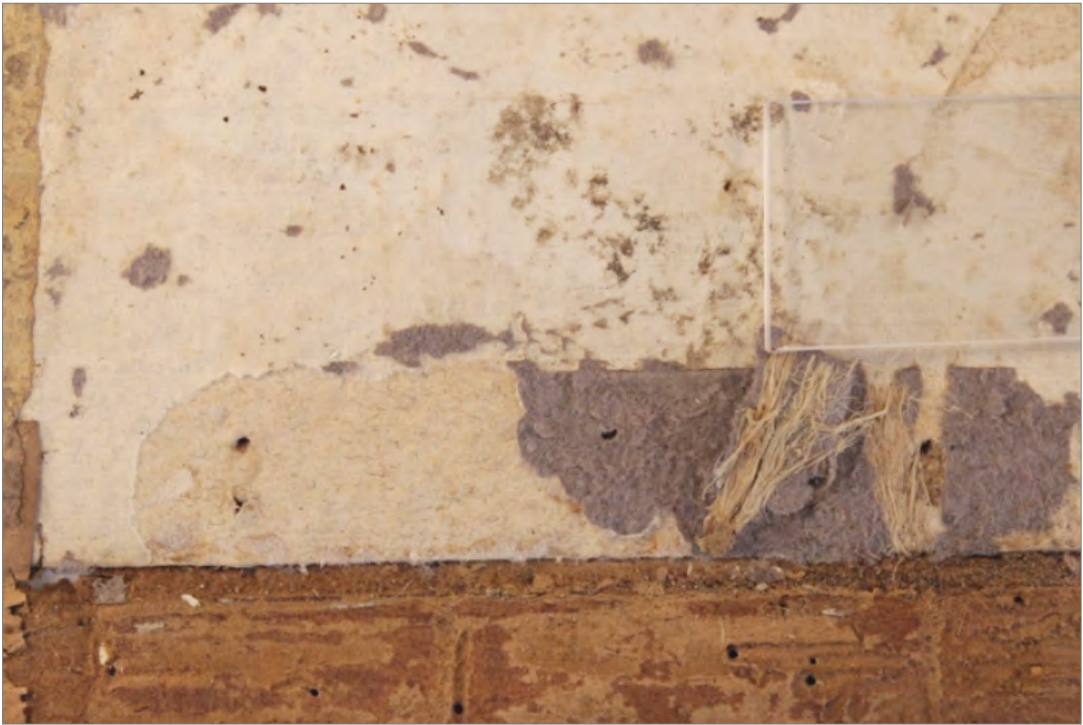
7. Double holes in the board

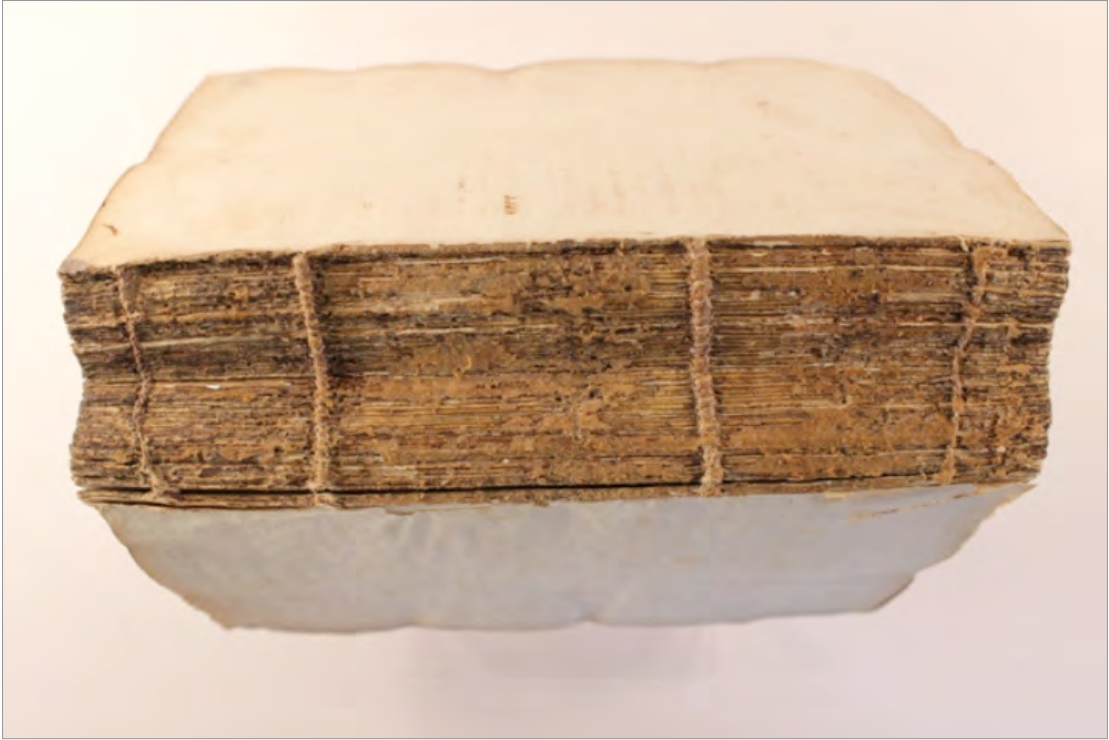
10. The disbound textblock

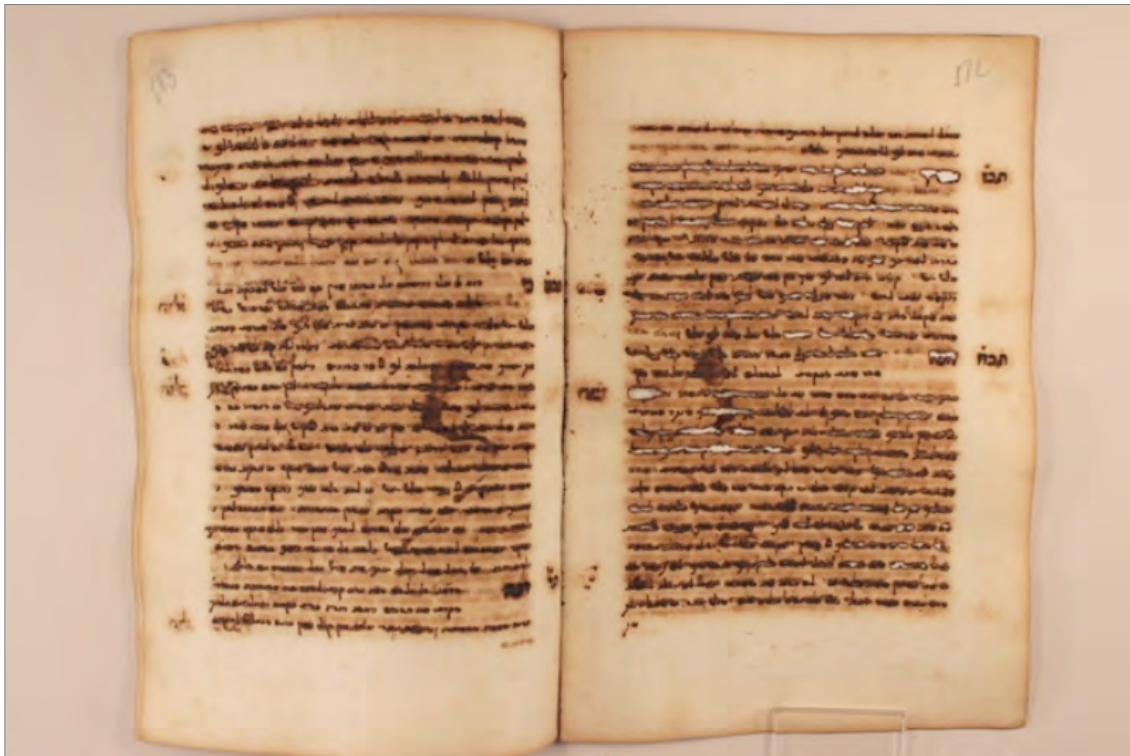
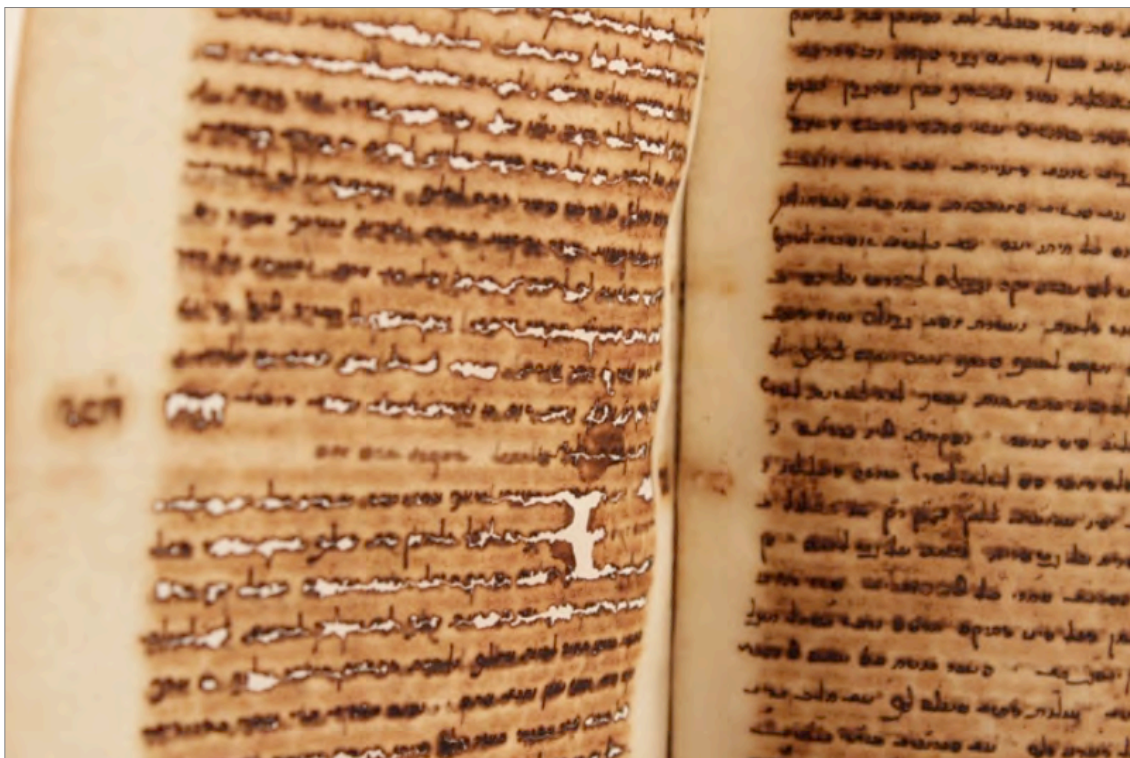
12-13. Different stages of ink corrosion

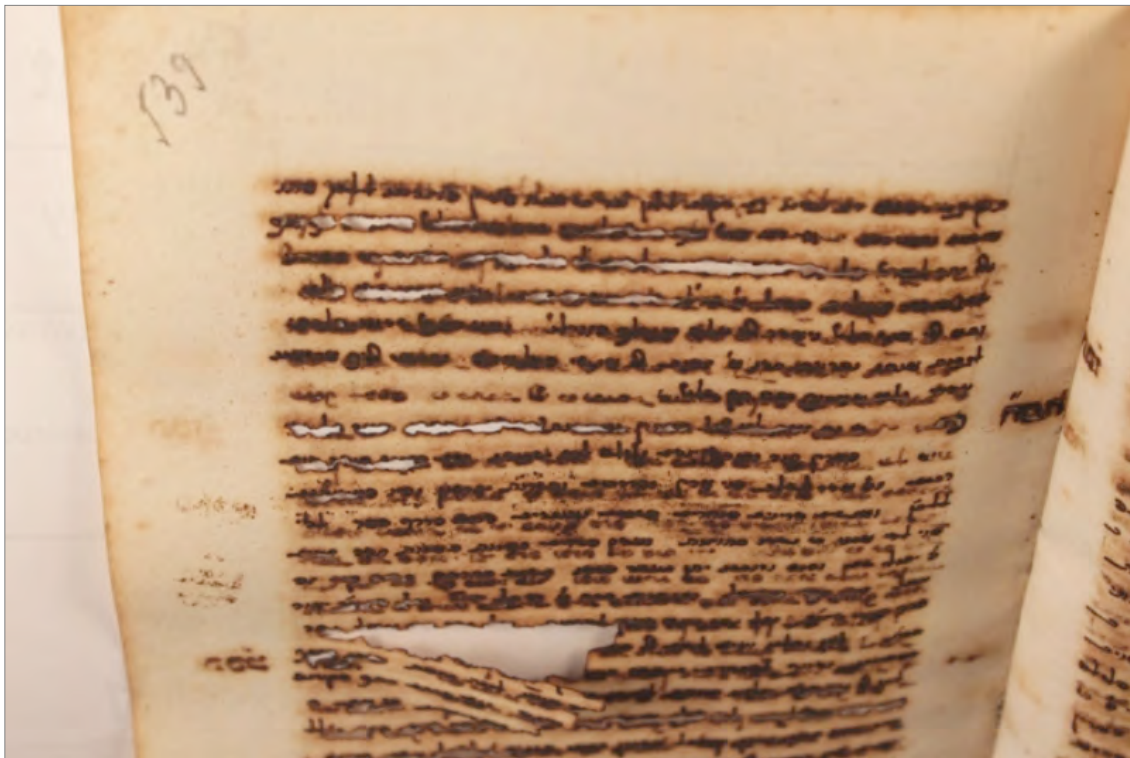
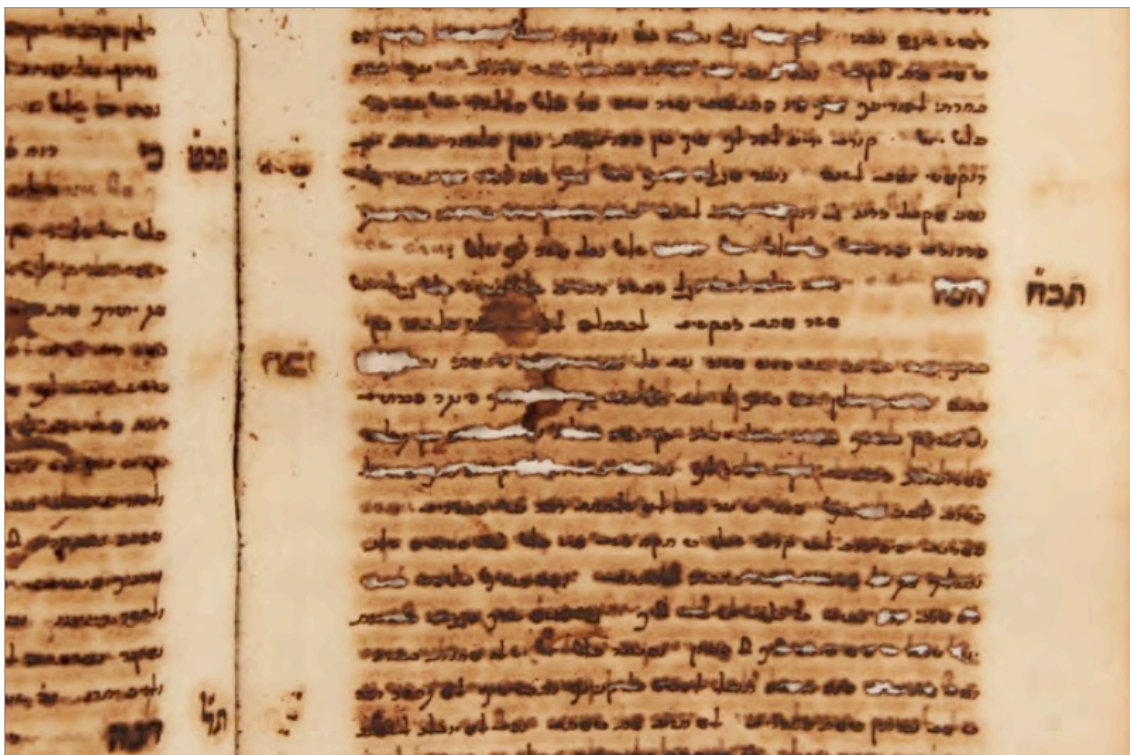
14-15. Severe losses due to ink corrosion
