RESTORATION REPORT

A78/II

PHOTOS

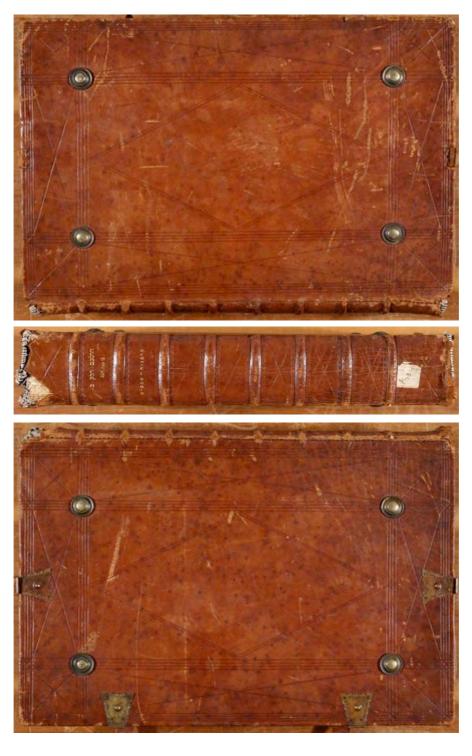
1. The binding of volume II

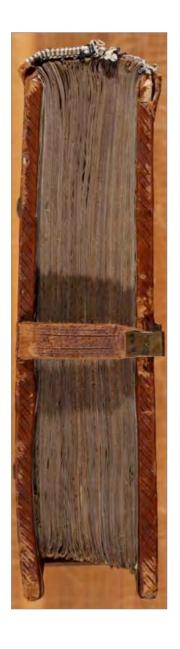
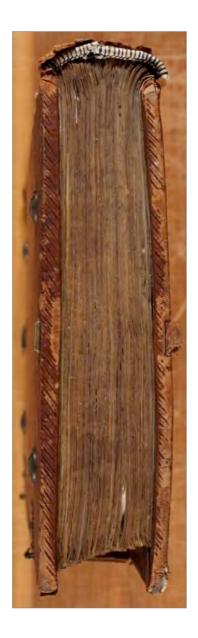
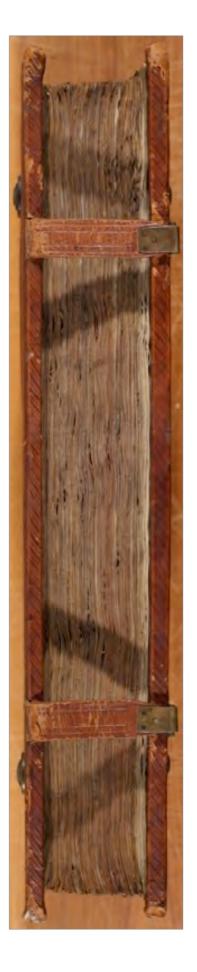
2. Edges of the volume with the missing clasp at tail

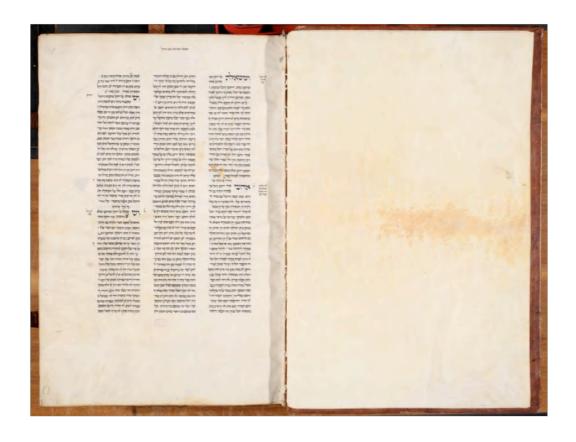
3. Right and left flyleaves

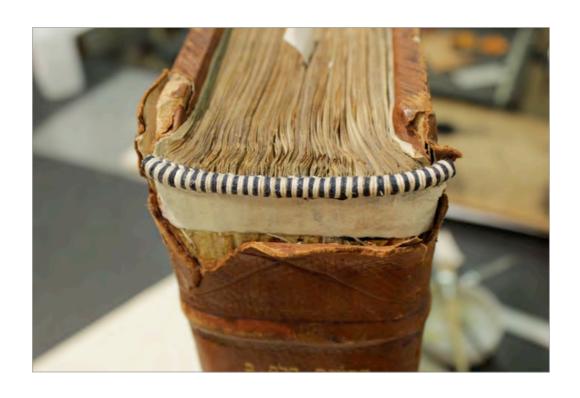
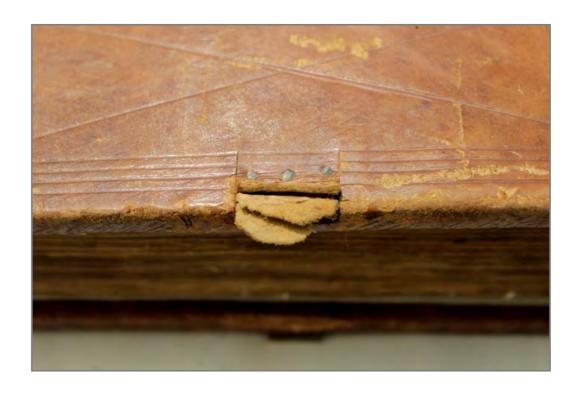
7. The missing stap
